PREFABRICATED POLYVINYLCHLORIDE EXTERNAL COAPTATION
FOR THE MANAGEMENT OF METACARPAL FRACTURE
IN A BREEDING MURRAH BUFFALO – A CASE REPORT

Adult 6 years old breeding Murrah buffalo bull weighing approximately 500 kg reported with the complaint of lameness in the left hind limb was diagnosed with complete metacarpal fracture based on the history and clinical examination. The fracture limb was stabilized by using a prefabricated polyvinylchloride (PVC) external coaptation. Anti-inflammatory and antibiotics injections along with serratopeptidase boluses were provided for a period of 7 days with restricted movement of the animal. Partial weight bearing of the affected limb was noticed after few weeks of immobilization and after 50 days the weight bearing was almost normal. Following the removal of the external splint, the animal could bear normal weight and no complication was reported thereafter.

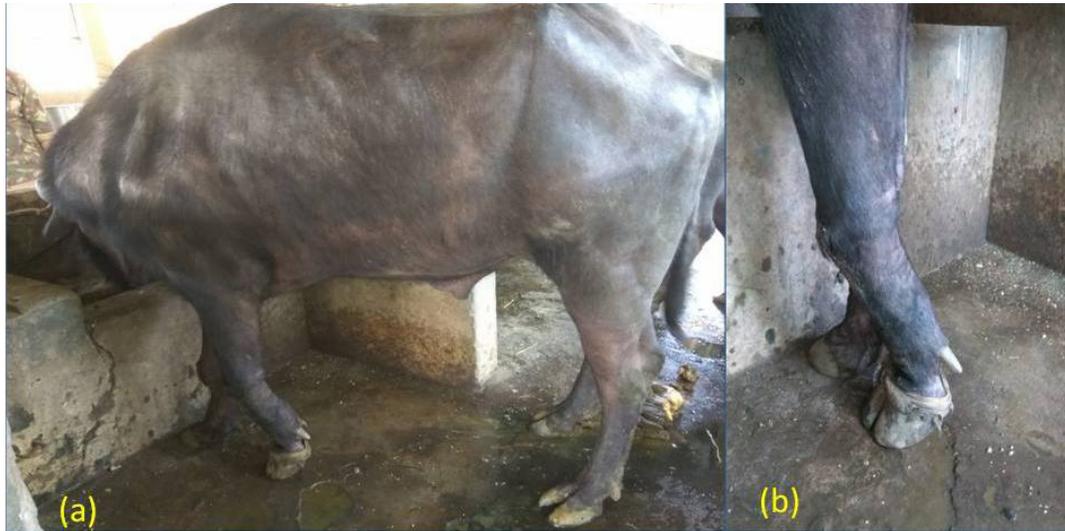
Figure 1. Showing inability to normal weight bearing on the affected left forelimb, (a and b).

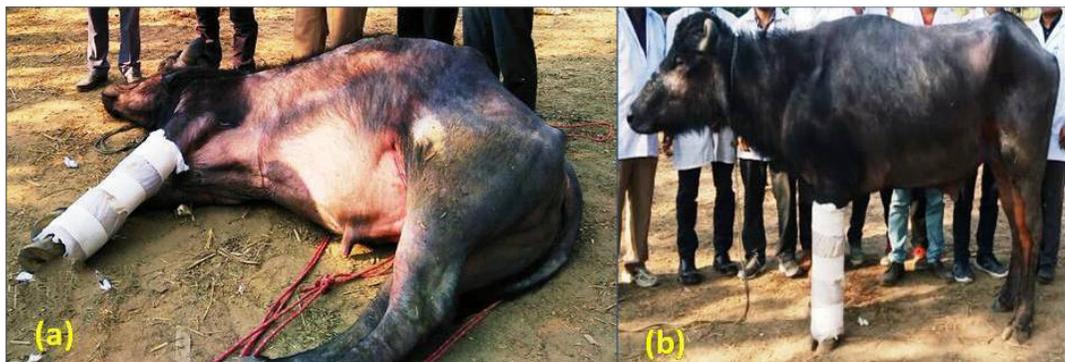
Figure 2. (a): Application of PVC splint in lateral recumbency after sedation and restraint.
(b): Buffalo bull in standing after application of PVC splint and complete recovery.

Prior to the day of surgery, a PVC splint (4" diameter, 10 mm thickness) was prepared after measuring the required length and diameter of the contralateral limb. The PVC pipe was first divided into two halves and the splint was contoured by applying adequate heat and fabricated according to the shape of the fore limb from elbow to hoof. A

Following 24 h fasting, the animal was sedated with xylazine (0.01 mg/kg, IM) and restrained in right lateral recumbency with the affected limb facing upwards after proper casting with rope and physical methods (Figure 2a). Reduction of the fracture bone was achieved by means of extension and counter-extension of the fractured limb and thick cotton padding was provided from elbow to hoof after applying boric acid powder. The prepared PVC splints were then applied carefully over the cotton padded limb covering all sides from medio-lateral to latero-medial angles. After accurate fixation of the PVC splint, the splints were tightened in place with adhesive tape throughout the length and circumference of the fabricated PVC splint and covered with polythene to protect from water contact (Figure 2b). Following complete immobilization, a course of anti-inflammatory (Inj. Flunixin meglumine 2.2 mg/kg, IM) and antibiotics (Inj. Enrofloxacin 5 mg/kg, IM) injections along with serratopeptidase boluses were provided for a period of 7 days with restricted movement of the animal. Partial weight bearing of the affected limb was noticed after few weeks of immobilization and after 50 days the weight bearing was almost normal (Figure 3a and 3b). Following complete removal of the external splint, the animal could bear normal weight and no complication was reported thereafter (Figure 4a and 4b).

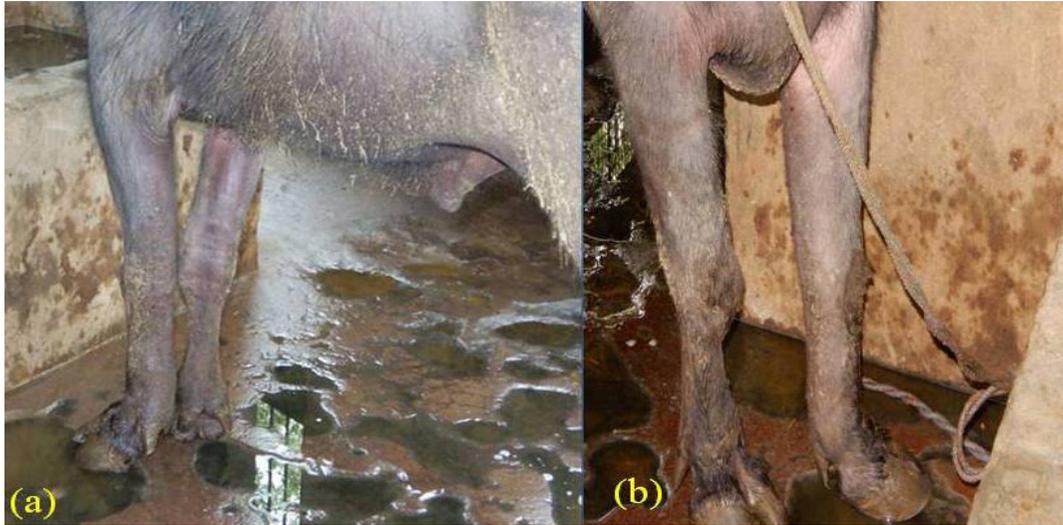
Figure 3. (a): Removal of PVC splint on 50 days. Almost to normal weight bearing observed on the left forelimb.
(b): Application of hydrotherapy after removal on PVC splint on 50 days.

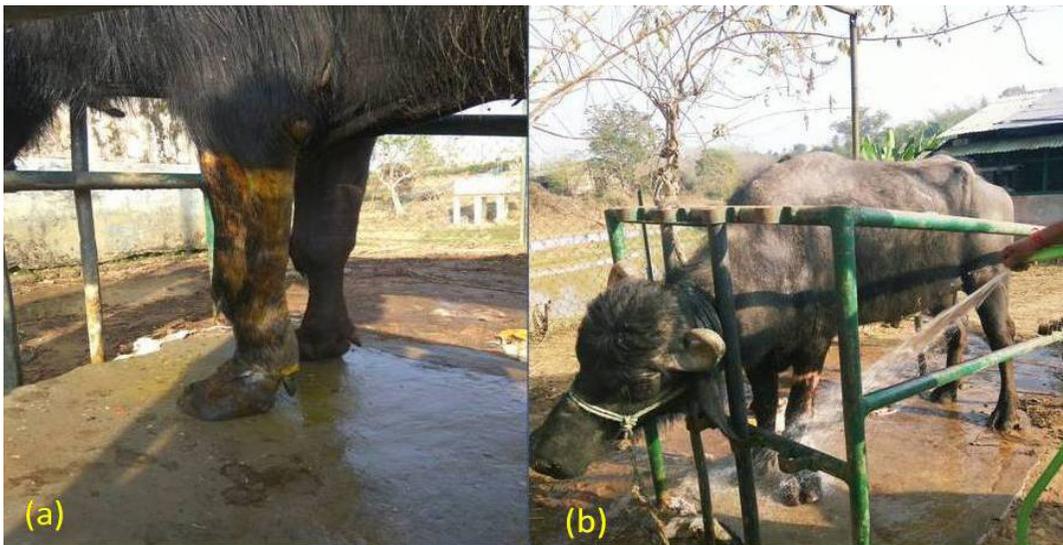
Figure 4. Normal weight bearing of the affected limb after 50 days of removal of PVC external coating.
